Multi Media Building – A Case Study - UACH

ABSTRACT: This paper compares 3 cases; the predicted results of the design of the Multi-Media Building at the Universidad Austral de Chile (UACH), the forecasted results of the what was actually constructed and the predicted results of the building had it been designed to conform to the proposed new building regulations in Chile. The energy consumption of the 3 cases is estimated. The results show that the actual construction and one built to the proposed new regulations building would consume around double the amount of energy as the intended design. It is noted that difference in energy consumption due to infiltration and thermal bridging is the same order of magnitude as that of the difference in transmission losses. The authors propose that these losses are a direct consequence of not following effective details avoiding thermal bridging and poor air tightness and that standard details for considering this should be drawn up for conventional Chilean building methods and materials to supplement the new regulations.

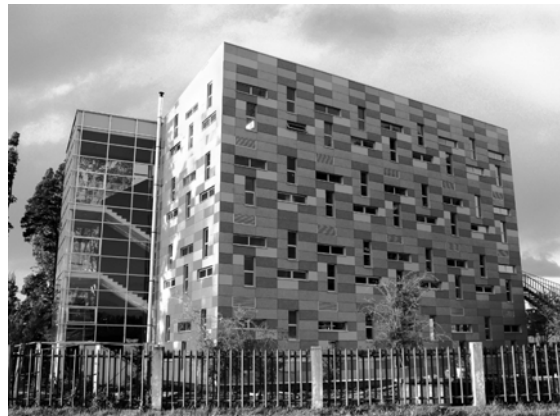
Figure 1: View of the Multi-Media Building from the South

The new Multi-Media building (Figure 1), at UACH, is an example of the continuing efforts to include energy efficiency, passive design and good indoor climatic conditions in the new buildings being constructed on the campus with the involvement of the School of Architecture. Basic bioclimatic principles of orientation, solar spaces, buffer zones, exterior insulation, nighttime cooling, etc have been incorporated in the design, still using conventional construction methods. Experience gained from a previous building on campus showed that more attention to the details (insulation, infiltration, thermal bridges) was necessary for the passive principles to be of any use [1]. However, these details have not been followed in the construction and the reasons and predicted results are discussed in this paper.

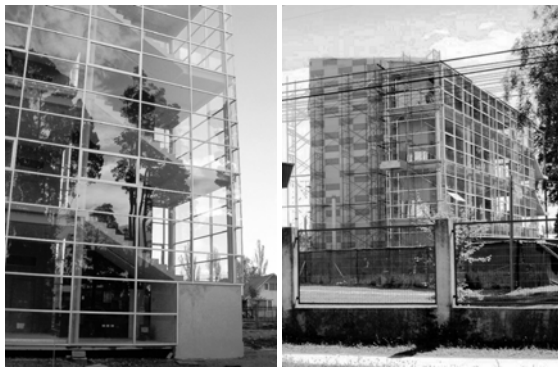
Figure 4: North façade and view of building from northeast

Figure 2 shows a typical floor plan of the building, with 2 Auditoriums per floor sharing a control room. To the north there is a circulation space enclosed in glass (Figure 4) that acts as a buffer zone for the hot

summer sun and a solar space to capture the sun heat in winter.
