# Multi Media Building – A Case Study - UACH

**ABSTRACT:** This paper compares 3 cases; the predicted results of the design of the Multi-Media Building at the Universidad Austral de Chile (UACH), the forecasted results of the what was actually constructed and the predicted results of the building had it been designed to conform to the proposed new building regulations in Chile. The energy consumption of the 3 cases is estimated. The results show that the actual construction and one built to the proposed new regulations building would consume around double the amount of energy as the intended design. It is noted that difference in energy consumption due to infiltration and thermal bridging is the same order of magnitude as that of the difference in transmission losses. The authors propose that these losses are a direct consequence of not following effective details avoiding thermal bridging and poor air tightness and that standard details for considering this should be drawn up for conventional Chilean building methods and materials to supplement the new regulations.

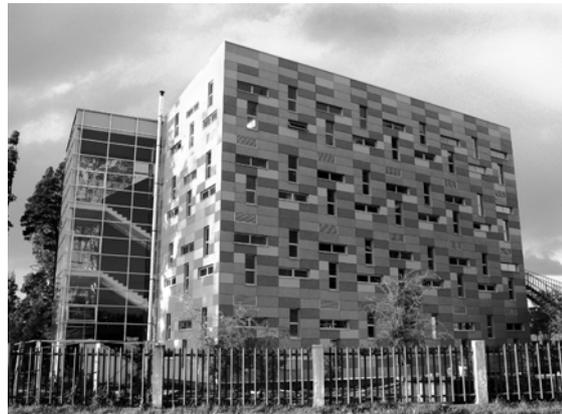
**Figure 1:** View of the Multi-Media Building from the South

The new Multi-Media building (Figure 1), at UACH, is an example of the continuing efforts to include energy efficiency, passive design and good indoor climatic conditions in the new buildings being constructed on the campus with the involvement of the School of Architecture. Basic bioclimatic principles of orientation, solar spaces, buffer zones, exterior insulation, nighttime cooling, etc have been incorporated in the design, still using conventional construction methods. Experience gained from a previous building on campus showed that more attention to the details (insulation, infiltration, thermal bridges) was necessary for the passive principles to be of any use [1]. However, these details have not been followed in the construction and the reasons and predicted results are discussed in this paper.

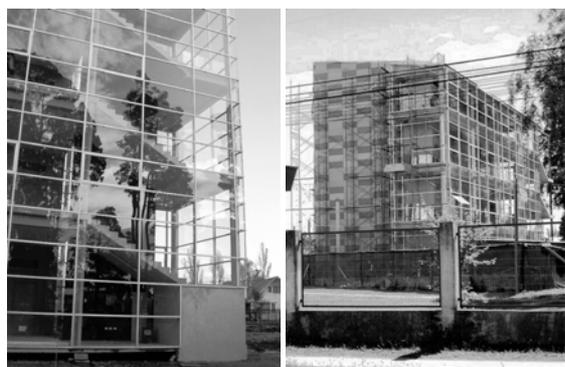
**Figure 4:** North façade and view of building from northeast

Figure 2 shows a typical floor plan of the building, with 2 Auditoriums per floor sharing a control room. To the north there is a circulation space enclosed in glass (Figure 4) that acts as a buffer zone for the hot

summer sun and a solar space to capture the sun heat in winter.
